Manhole Inspection Summary

Manhole # S51C__021MH

Insp Date: **5/1/08 9:39 AM**

Location Address: **2800 e fairmont ave**

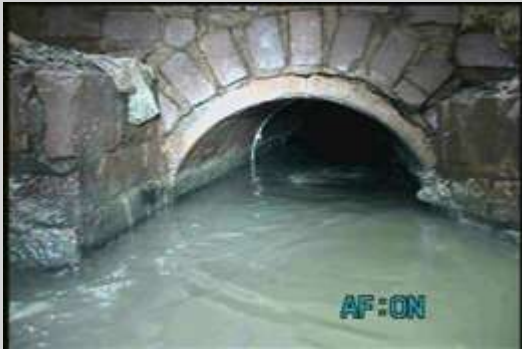
12 O'Clock Outflow

18 in. Circular Gravity Sewer
Pipe Out @ 12 O'Clock

Pipe Material: **Clay** ☐ Pipe Lined

Invert Depth: **13.70** (ft.) Flow Characteristics: **Fast**

Infiltration: **None** Pipe Seal Cond: **Unknown**

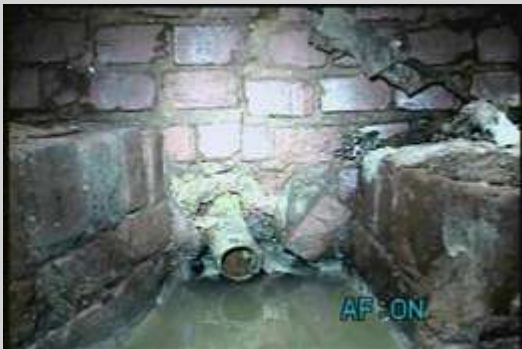
3 O'Clock Inflow

8 in. Circular Gravity Sewer
Pipe In @ 3 O'Clock

Pipe Material: **Clay** ☐ Pipe Lined

Invert Depth: **13.10** (ft.) Flow Characteristics: **Fast**

Infiltration: **None** Pipe Seal Cond: **Unknown**

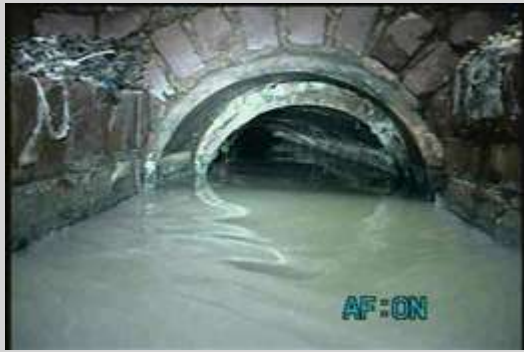
6 O'Clock Inflow

18 in. Circular Gravity Sewer

Pipe In @ 6 O'Clock

Pipe Material: **Clay** ☐ Pipe Lined

Invert Depth: **13.50** (ft.) Flow Characteristics: **Fast**

Infiltration: **None** Pipe Seal Cond: **Unknown**

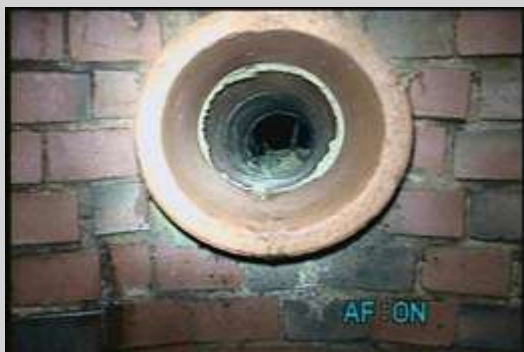
9 O'Clock Inflow

8 in. Circular Gravity Sewer

Pipe In @ 9 O'Clock

Pipe Material: **Clay** ☐ Pipe Lined

Invert Depth: **8.90** (ft.) Flow Characteristics: **Fast**

Infiltration: **None** Pipe Seal Cond: **Unknown**

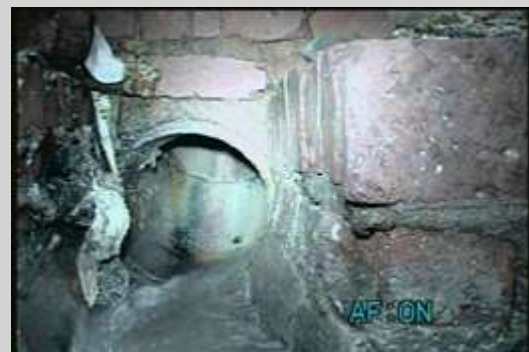
Drop In @ 9 O'Clock

Drop: **Outside Direct**

Inv Depth: **13.00** (ft.)

Drop Condition: **Open**
